# TELL FARAMA

## (Pelusium)

### PRELIMINARY REPORT ON SECOND SEASON OF POLISH-EGYPTIAN EXCAVATIONS

Krzysztof Jakubiak

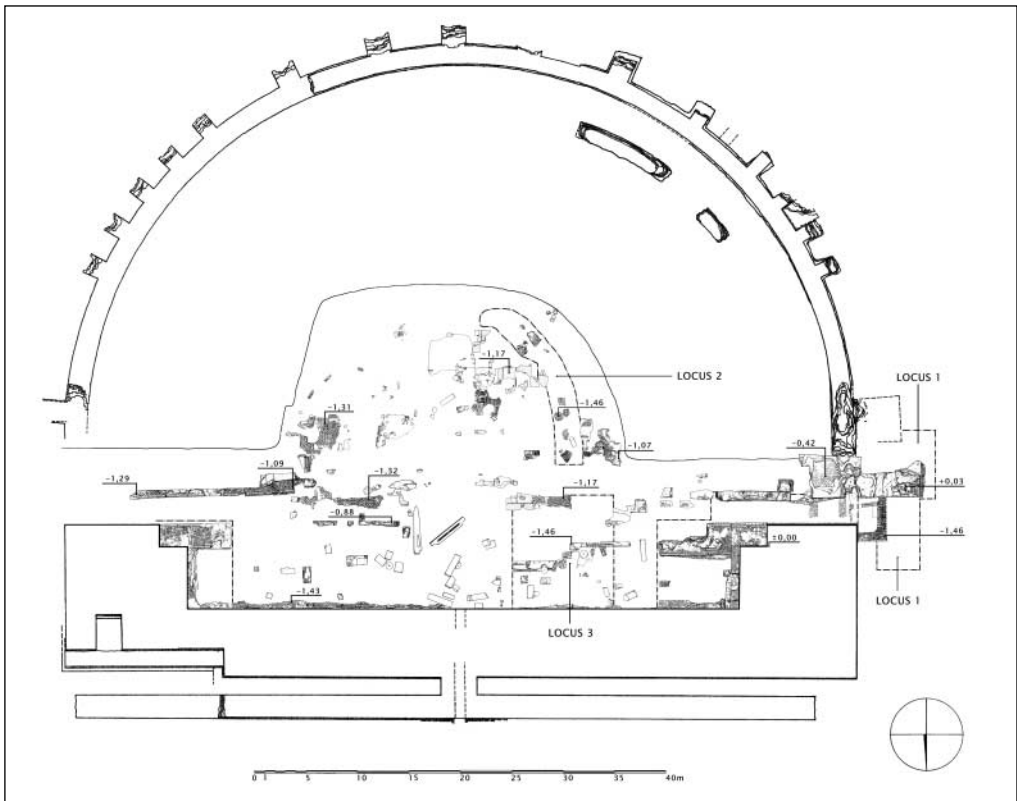
Fig. 1. Plan of the theater at Tell Farama (Pelusium) after the 2004 season (Drawing M. Smota, S. Maślak, K. Jakubiak)

*The second campaign of fieldwork at the site of the theater at Tell Farama (ancient Pelusium) was carried out between July and August 5, 2004.<sup>1</sup> The work was generally a continuation of the first season's efforts, focusing particularly on the orchestra area. The latter was greatly aided by the cleaning of a big part of the structure, carried out in the spring season by Dr. Ahmed Taba'i from the SCA. Further trenches were located in the western and northern parts of the monument, exploring respectively the entrance to the theater parodos and the area between the scenae frons and the pulpitum (Fig. 1)*

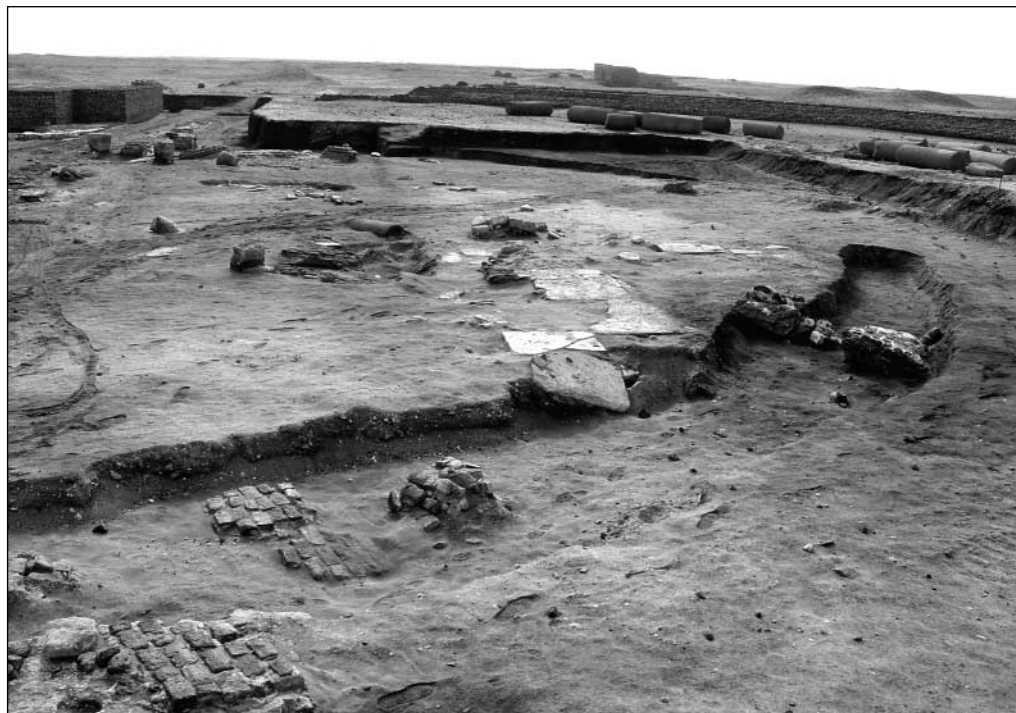
Fig. 2. Orchestra area, view from the west. After excavations (Photo K. Jakubiak)

Following the combined Egyptian and Polish clearing work in 2004, the entire area of the *orchestra* has been cleaned and studied [Fig. 2]. It is now evident that the stratigraphy of the site is completely disturbed and some parts of the red brick substructures have been damaged by heavy equipment. The damages seem to have been incurred during the Israeli occupation of the area. Missing marble and limestone slabs from the original pavement reflect an earlier phase of destruction, when the ruins were used locally as a ready source of building material.

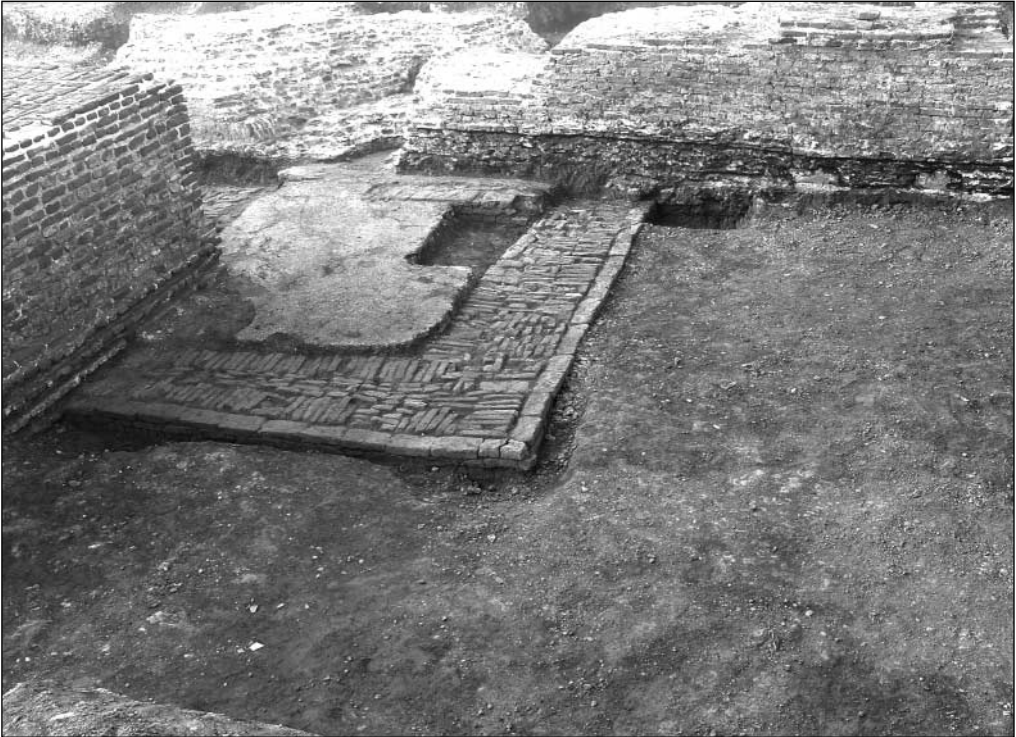
Fig. 3. Hellenistic or early Roman structure under the eastern parodos  
(Photo K. Jakubiak)

Moreover, a late Hellenistic or early Roman structure [Fig. 3] was discovered in the spot where an entrance from the earlier phase had been assumed. The building technique (red bricks and concrete pavement) suggested a date for the structure in

the early 1st century AD. Obviously, the theater was built in place of earlier structures, but it is still premature to decide whether the choice of site under the theater was determined by the fact that it lay abandoned or whether the project was part of more extensive urban planning activities.

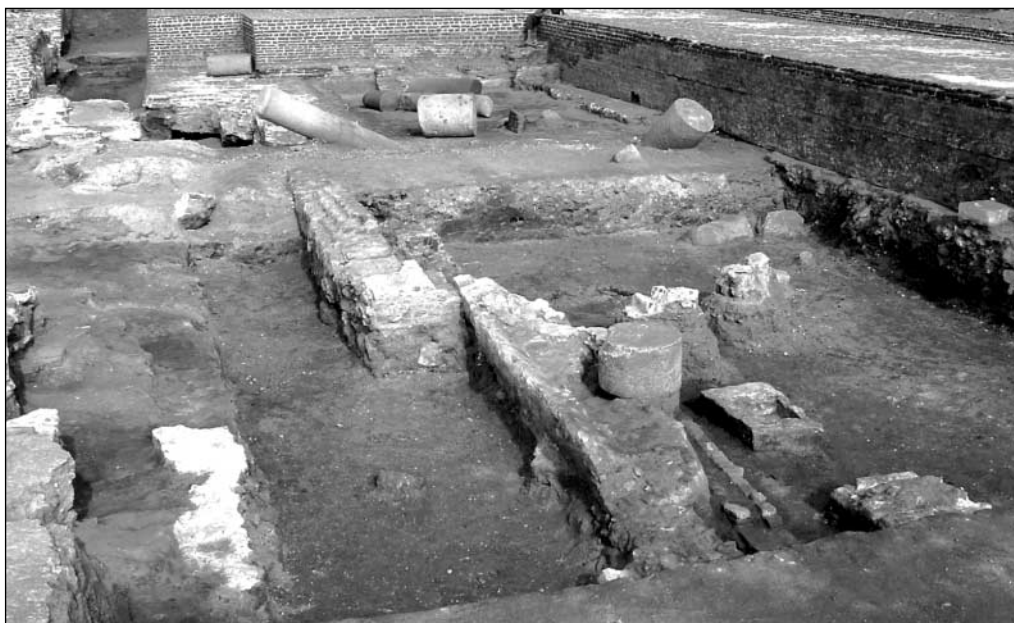
*Fig. 4. Trench in the northern part of the theater, view from the east/southwest (Photo K. Jakubiak)*

A third area explored in 2004 was located in the northern part of the theater, where the purpose of opening excavations was to see how the area between the *scenae frons* and *pulpitum* had been organized. The trench measured 9.50 by 10.50 m [Fig. 4]. Quantities of bronze and iron nails found here supported the idea of wooden planks being used here. This year's excavations concentrated on the foundation of the *scenae frons* wall, revealing a similar

building technique as described above for the parodos entrance. Installations present at the foundation level between the *pulpitum* and *scenae frons* were also revealed, permitting a look at layers underlying the theater ruins. It was also discovered that following the abandonment of the theater, the ruins were reused for some kind of industrial activity (lime processing?), as suggested by the remains of two water-supply channels constructed with the use of pieces of architectural decoration, which could have been retrieved from the decoration of the *scenae frons* [Figs. 5,6]. Relevant pottery finds from a layer containing lime and crushed red bricks indicated a date not earlier than the late 4th and early 5th century for these late installations.

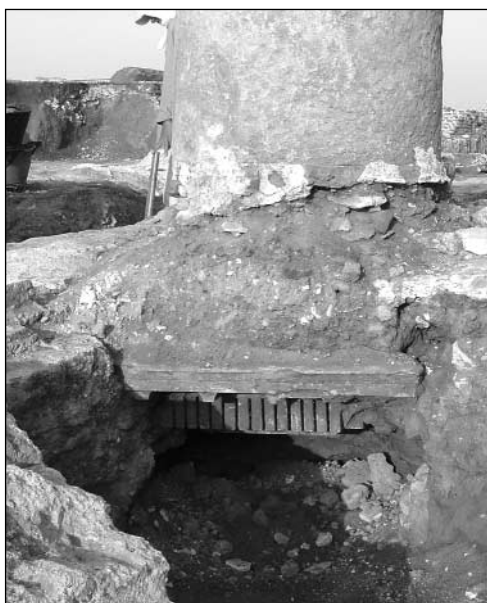
*Fig. 5. Reused cornice block in situ in a late channel installation built into the theater ruins, view from the east (Photo K. Jakubiak)*

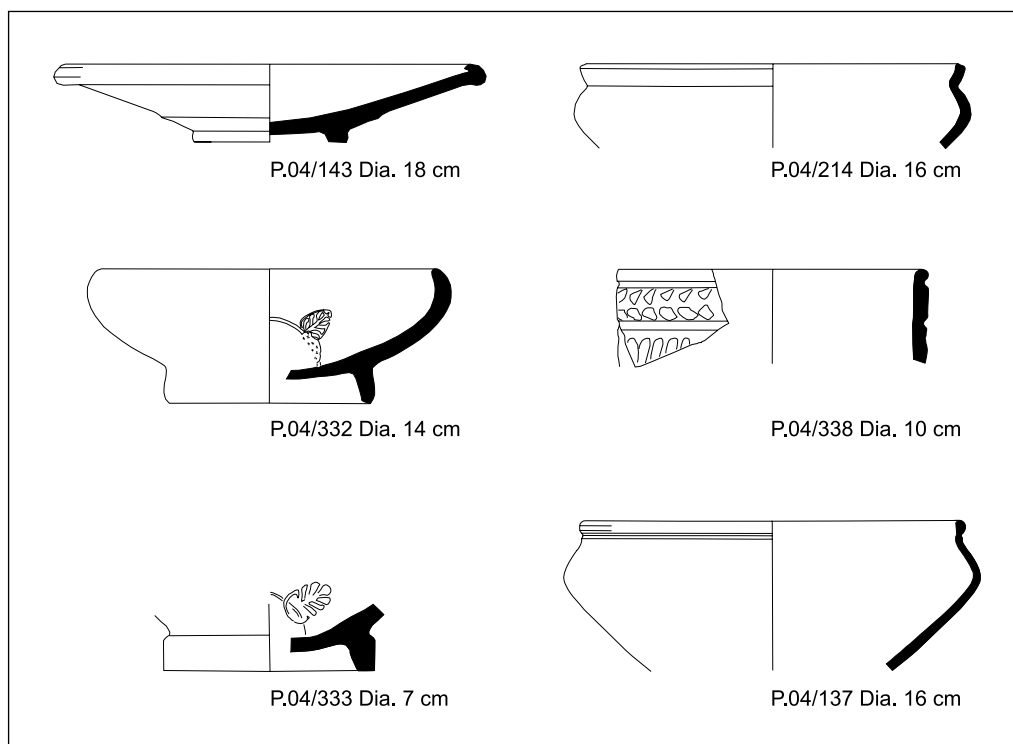
*Fig. 7. Examples of Hellenistic and Early Roman fine tablewares from the dump (Drawing K. Jakubiak)*

Meriting attention among the fine wares [*Fig. 7*] were the black-gloss goblets, both local and imported. A cup of the 2nd century BC could be an import from

Cyprus. Also, plates and bowls from this period were of very good quality (P.04/143, P.04/214, P.04/332, P.04/333, P.04/338). Among the Roman-period pottery, one should mention a Cypriot-sigillata bowl (P.04/137) and an unguentarium, dated to the 1st century AD.

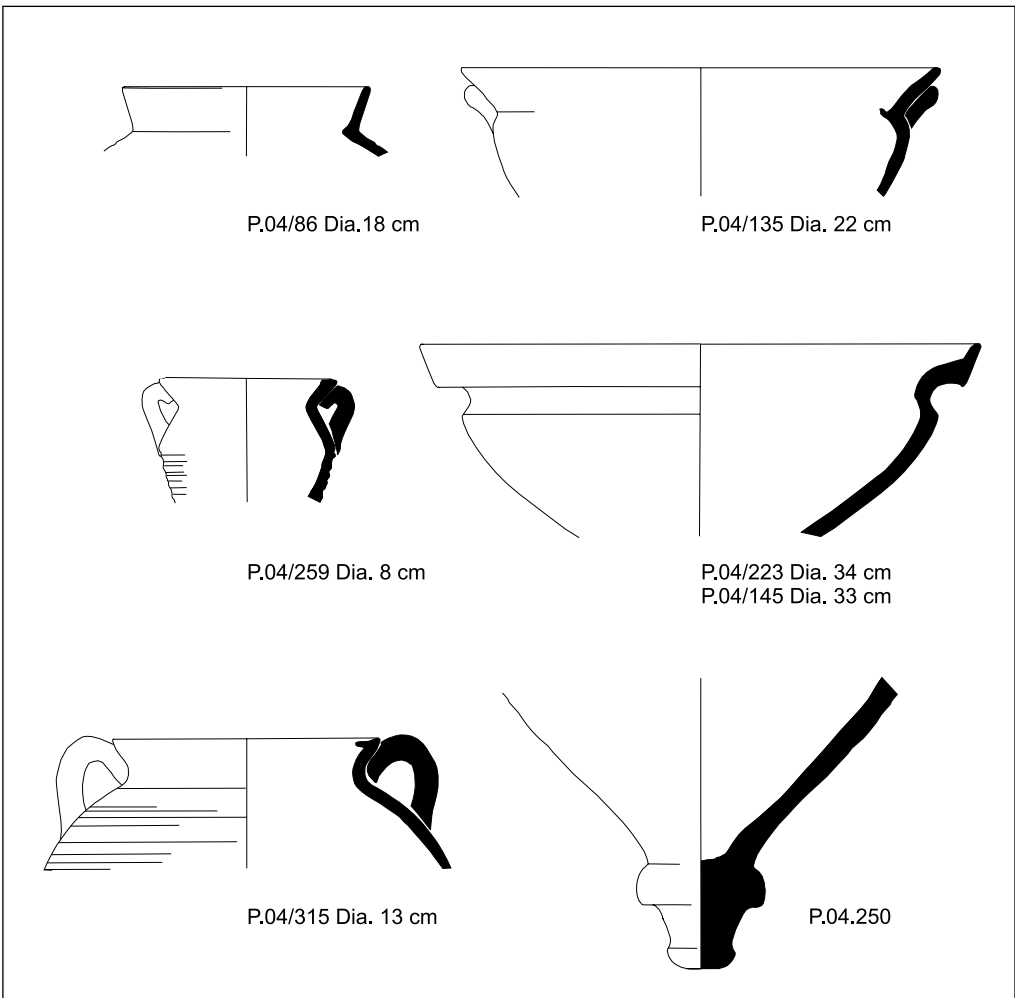
Fig. 8. Examples of Hellenistic and Early Roman plain and cooking wares, and storage containers from the dump (Drawing K. Jakubiak)

The remaining pottery material dated roughly from the 2nd century BC to the 1st century AD and included a representation of both fine tableware and plain and cooking wares, as well as some amphorae, although these were relatively few (e.g. P.04/250, cf. *Fig. 8*).

Examples of cooking ware included cooking pots and casseroles (e.g. P.04/86, P.04/135, cf. *Fig. 8*), both dated to the late 1st century BC, and cooking pots, most of which were of Hellenistic date, except for a few, like P.04/259 or P.04/315 (*Fig. 8*), which could have been either Late Hellenistic or Early Roman. Of approximately the same period were the coarse wares, including two fragments of overhanging rim kraters (Fig. 8: P.04/145 and P.04/223),

which could be dated to the 1st century AD, again confirming the mixed nature of the deposit. Bowls were the most popular form of coarse ware.
